WOOD DESTROYING PESTS AND ORGANISMS INSPECTION REPORT

BUILDING NO. 812	STREET, CITY, STATE, ZIP ROSEMOUNT ROAD, OAKLAND CA 94610	Date of Inspection 10/17/2007	No. of Pages 9
----------------------------	---	---	--------------------------

EAST BAY STRUCTURAL & TERMITE COMPANY

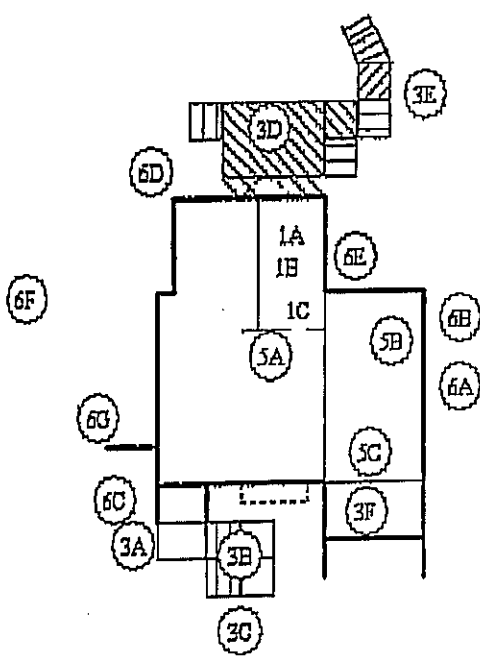
An inspection has been made to the structure(s) shown on the diagram in accordance with the Structural Pest Control Act. Detached porches, detached steps, detached decks and any other structures not on the diagram were not inspected.
